# ANATOMY OF A VALVE FAILURE

Burned exhaust valves have long been a leading cause of cylinder failures and power loss in piston aircraft engines. Modern borescopes allow us to look deep inside cylinders—and this guide will help you interpret what you see through the viewfinder.

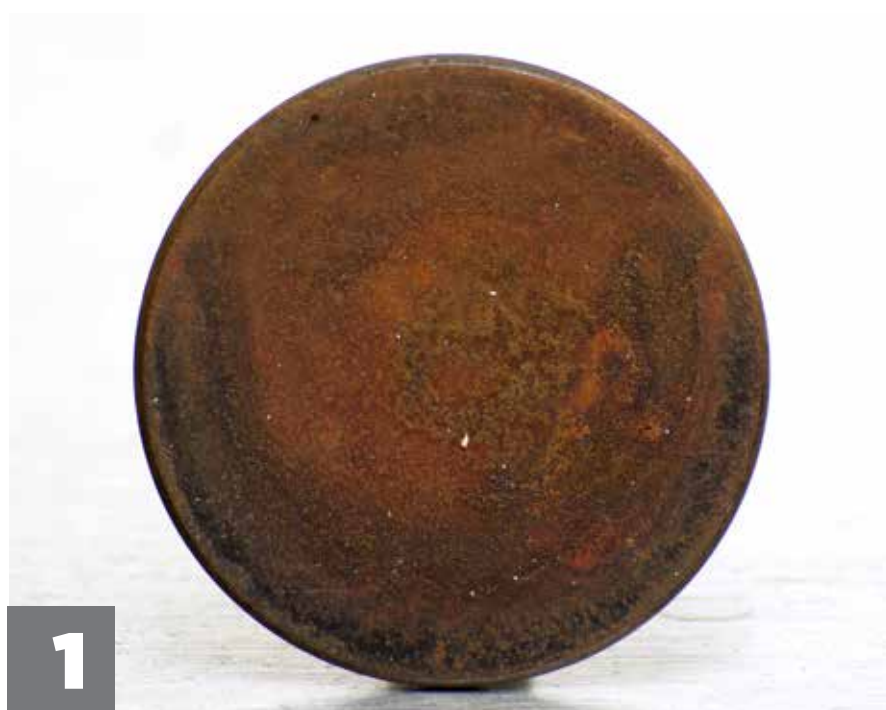
**1** First indication: Circular color pattern is slightly uneven and nonsymmetrical.

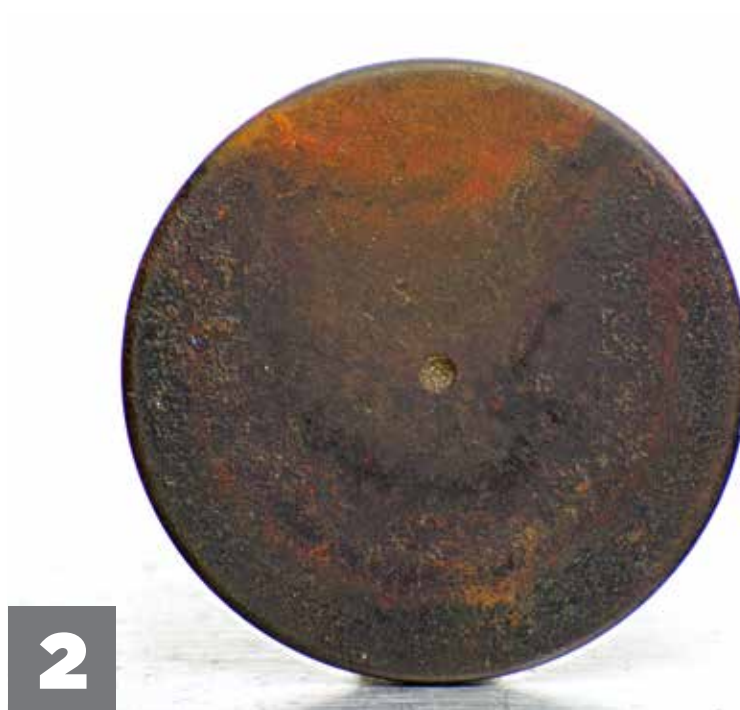
**2** Crescent-shape, discolored burn pattern developing at upper edge.

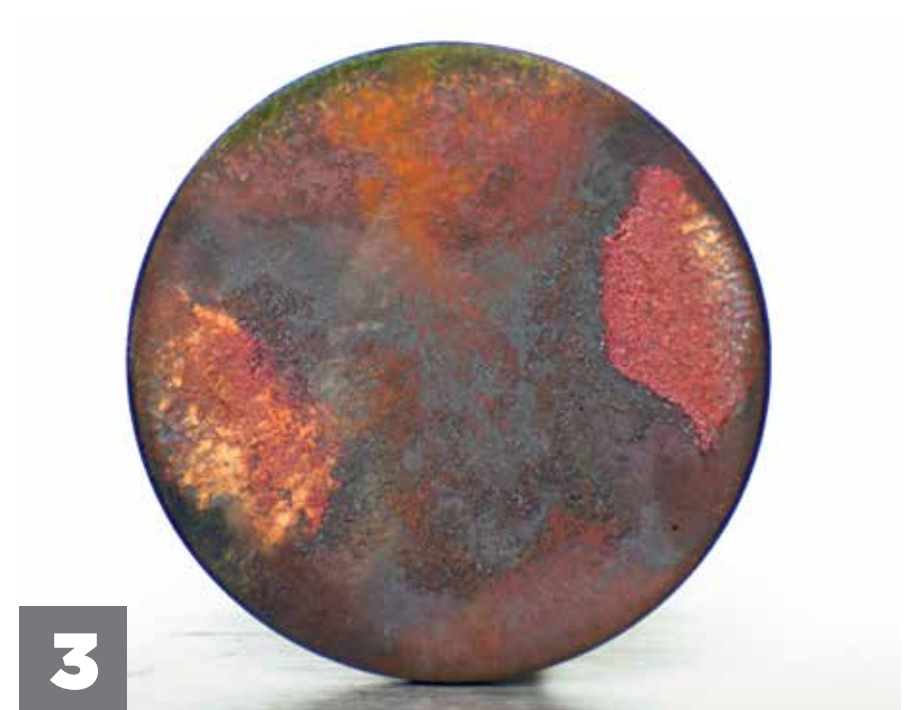
**3** Burn pattern migrates inward.

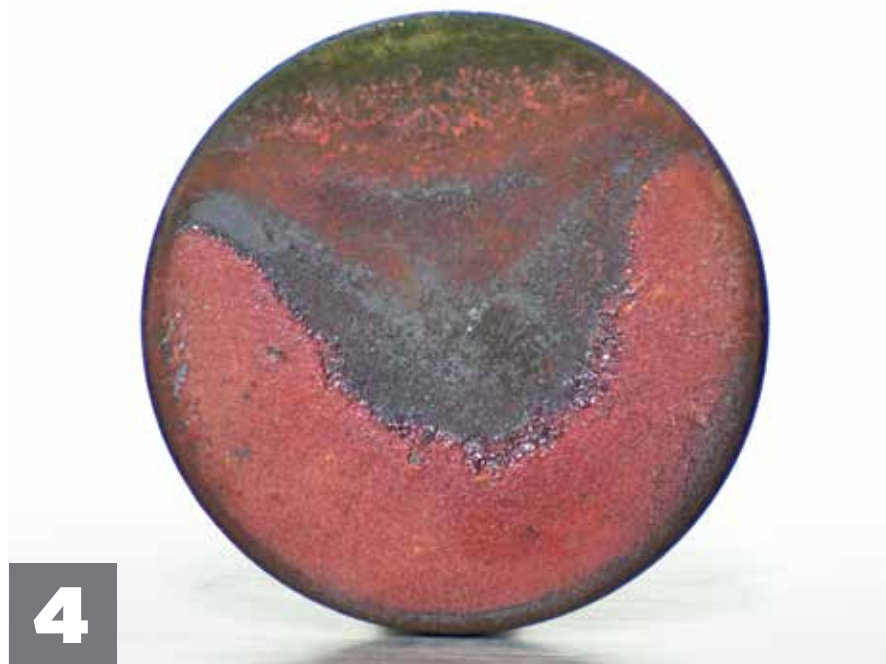
**4** **GREEN MEANS STOP.** The green area at the top shows this **valve should be replaced immediately.** (Note how the uneven burn patterns match the heat distribution chart.)

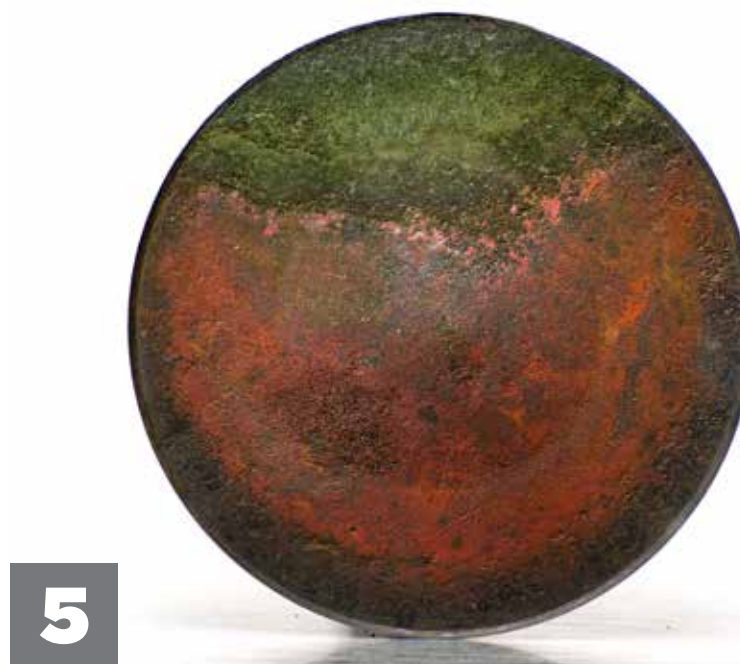
**5** Green crescent progresses toward center with valve cracking and failure a serious danger.

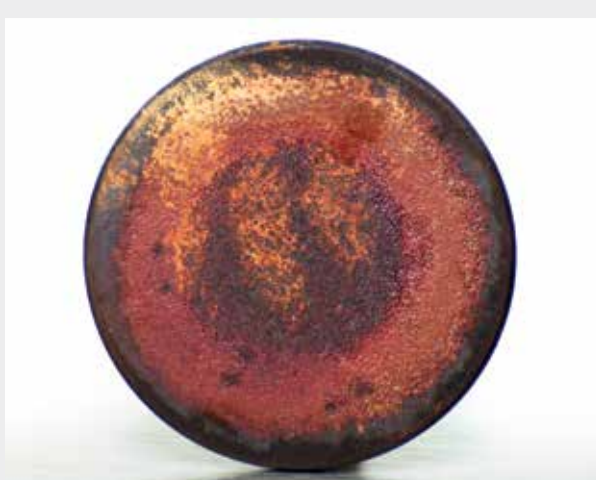
Don't be alarmed by the bright color, or deposits around the edges. The symmetrical pattern shows this valve is just fine.

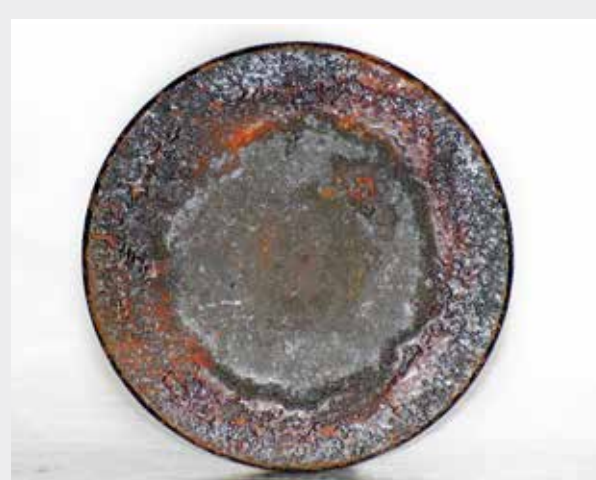
A symmetrical, circular pattern shows a healthy valve. Red and orange deposits are harmless.

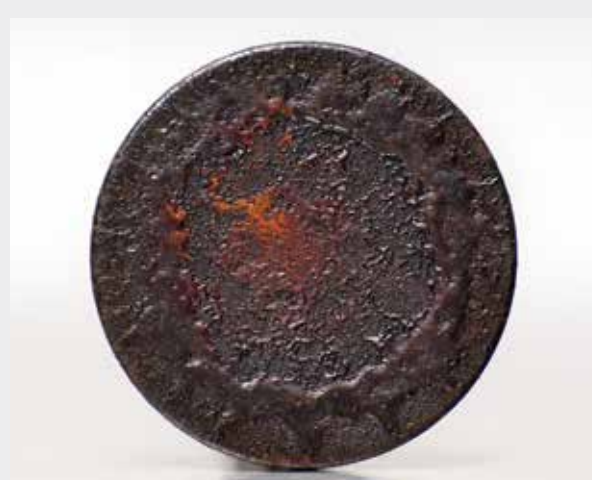
Thick lead deposits from an overly rich mixture give this healthy valve the appearance of an overcooked pizza.
